APDES Inspection Report

Permit # AKR06AA14

Auke Bay Ferry Terminal

August 16, 2016

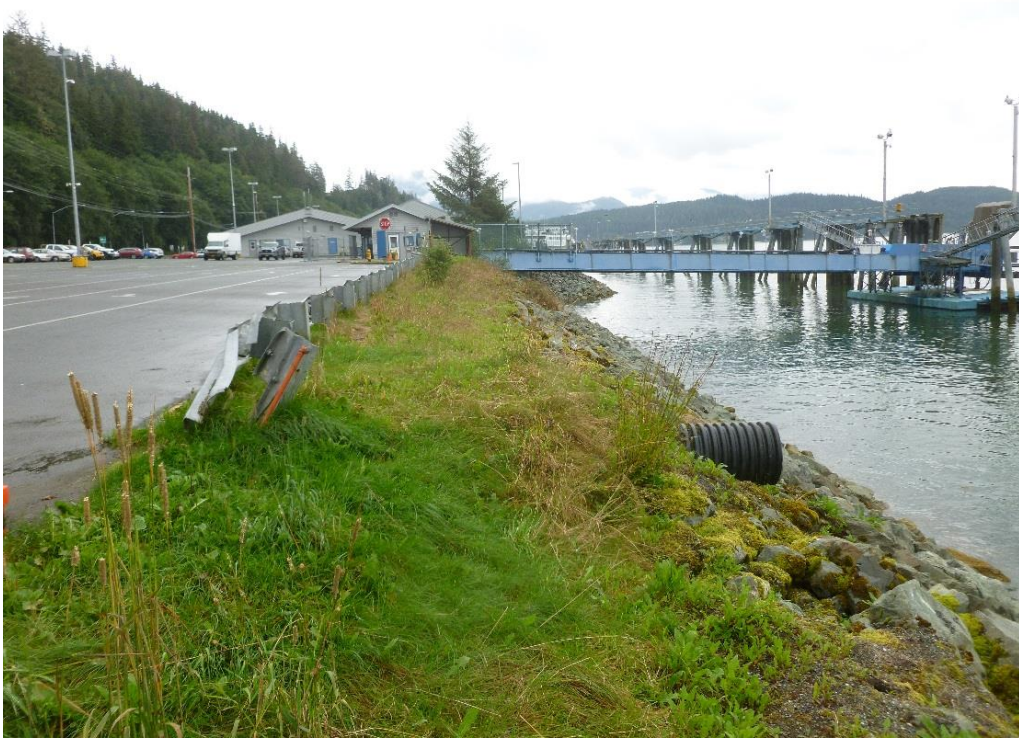
Photo 1 / P1020456 – Easterly view of outfall 1 with the terminal in the background

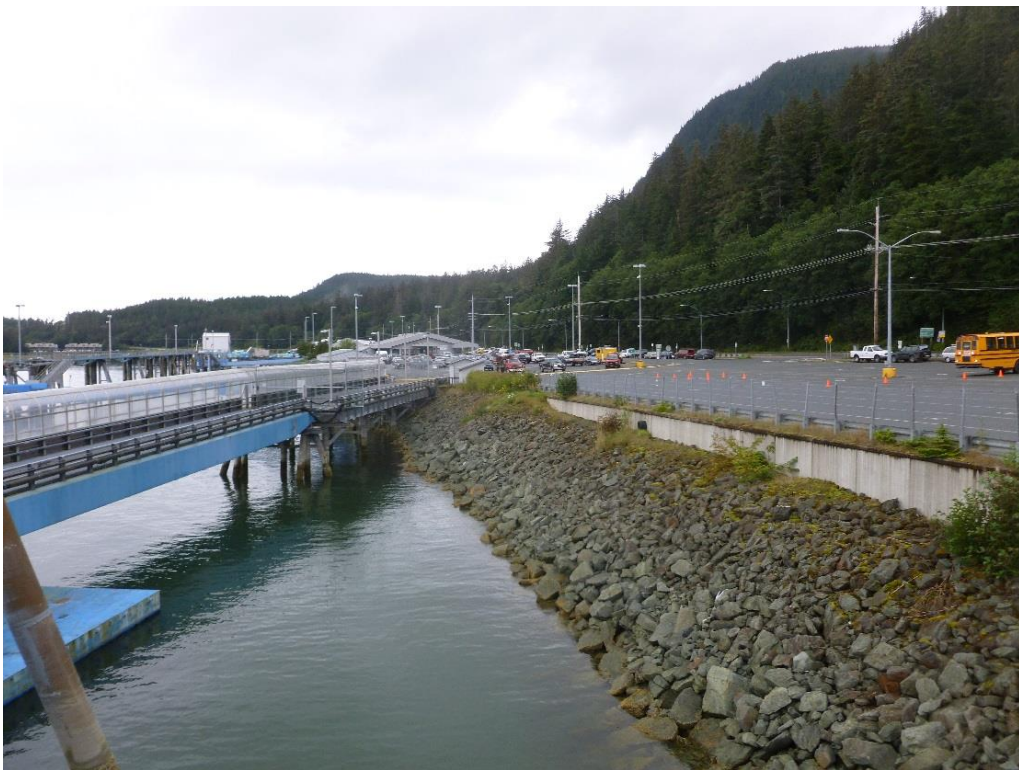
Photo 2 / P1020464 – Northwesterly view of the facility

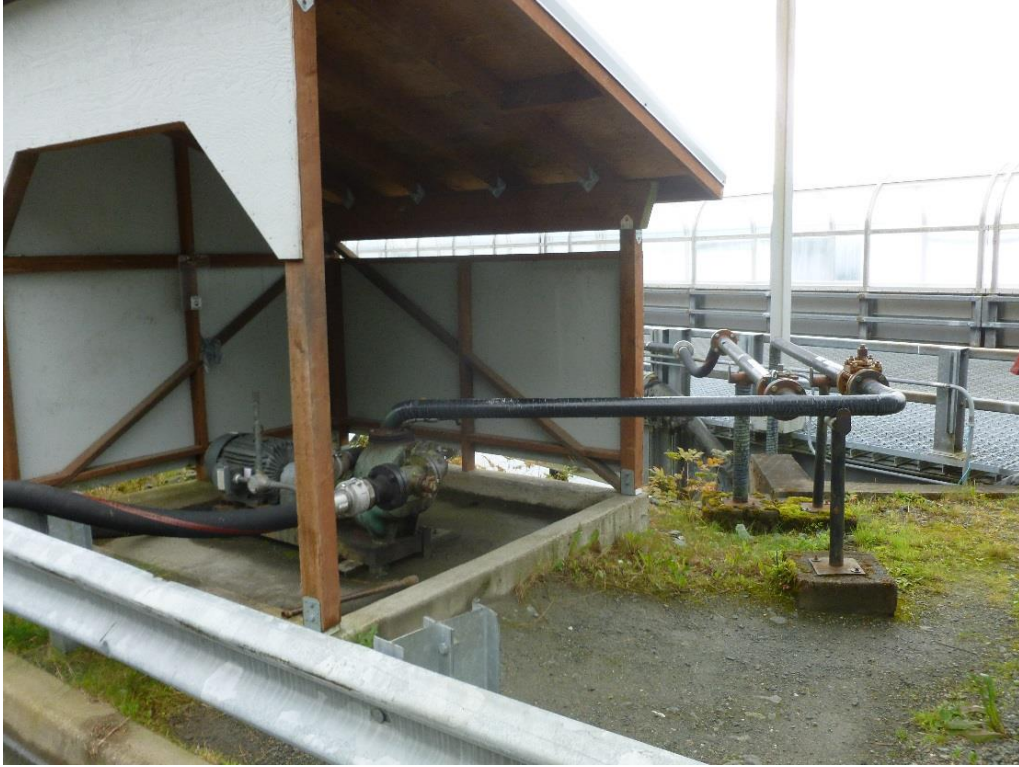
Photo 3 / P1020461 – Fueling pump station near Dock 1

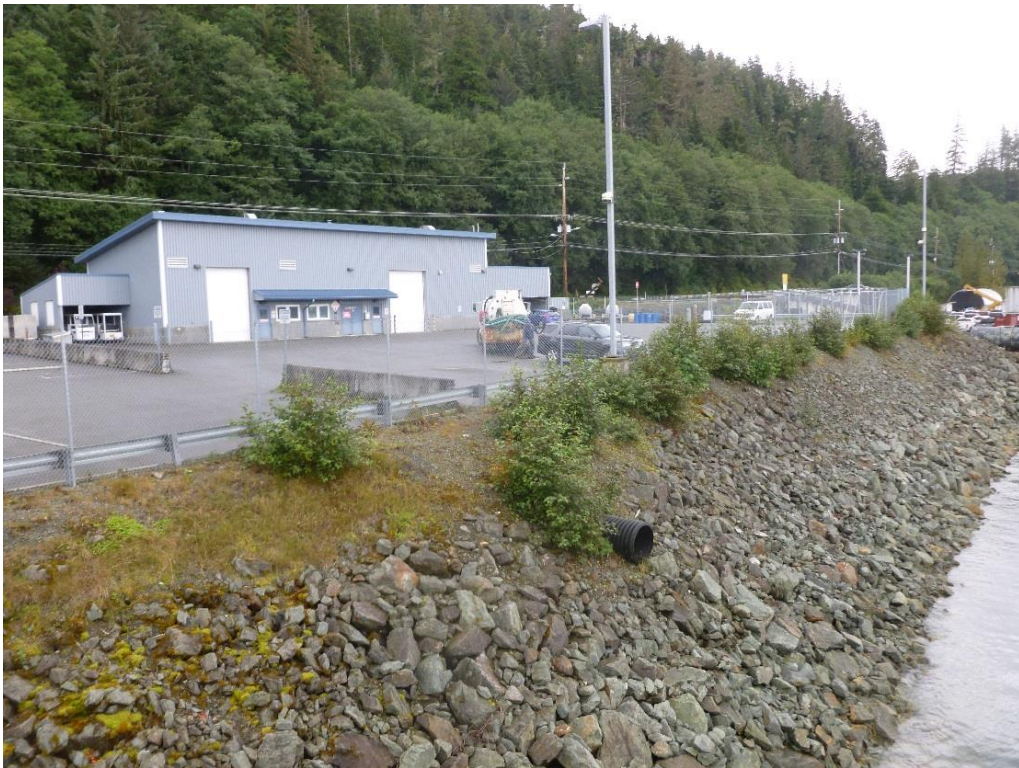
Photo 4 / P1020463 – Northeasterly view of the Fairweather Maintenance Building on the east side of the facility
